Report on the status of restored oyster reefs in the Loxahatchee River Estuary, Florida: nine years post-construction

2019 Assessment

Loxahatchee River District (LRD)

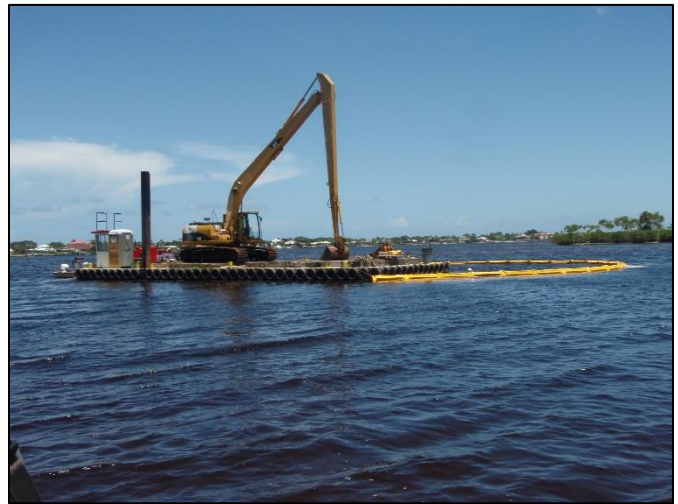
Photo 1. Image shows barge equipped with a long-arm excavator used to deploy shell material onto the oyster restoration sites during summer of 2010.

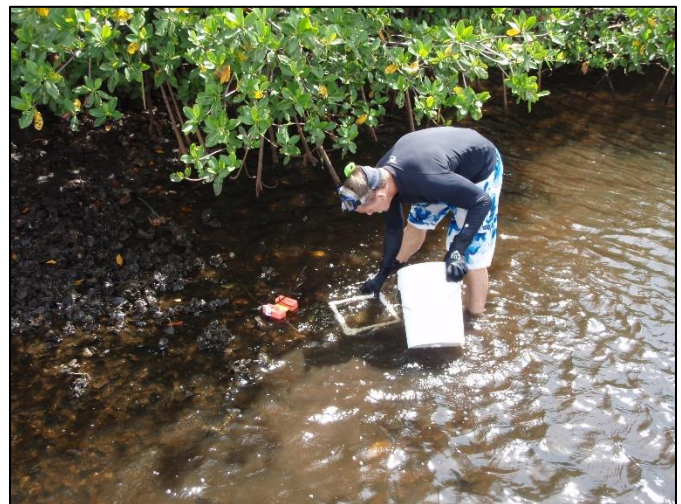
Photo 2. *Diver demonstrating oyster sample collection. Image shows orange marker buoy, 25 cm X 25 cm weighted quadrat, and collection bucket. Image taken at a natural oyster reef.*

At the oyster sampling sites, the hand-held GPS was used to navigate to each sample point where a weighted buoy was deployed to mark the point’s location. Divers equipped with snorkeling gear placed a 25cm X 25cm weighted PVC quadrat over the marked location and excavated shell material inside the quadrat to a depth of 10 cm or until no reef material remained (Photo 2). Excavated material was returned to a nearby boat and examined by staff who measured and counted oysters that had settled on the material.

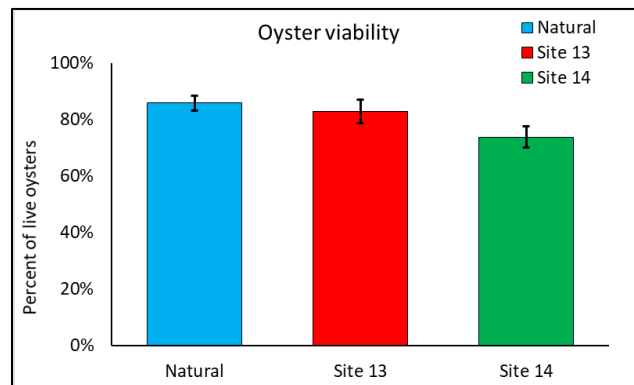
good viability (Figure 3) with Site 13 (82.9%; SD \pm 12.9%) closely mirroring the Natural reef (85.8% SD \pm 11.7%). Oyster viability at Site 14 was only slightly lower at 73.8% (SD \pm 24.2%).

Figure 3. Oyster viability as mean percentage of all oysters at each Reef that were alive. Error bars indicate 1 SE.

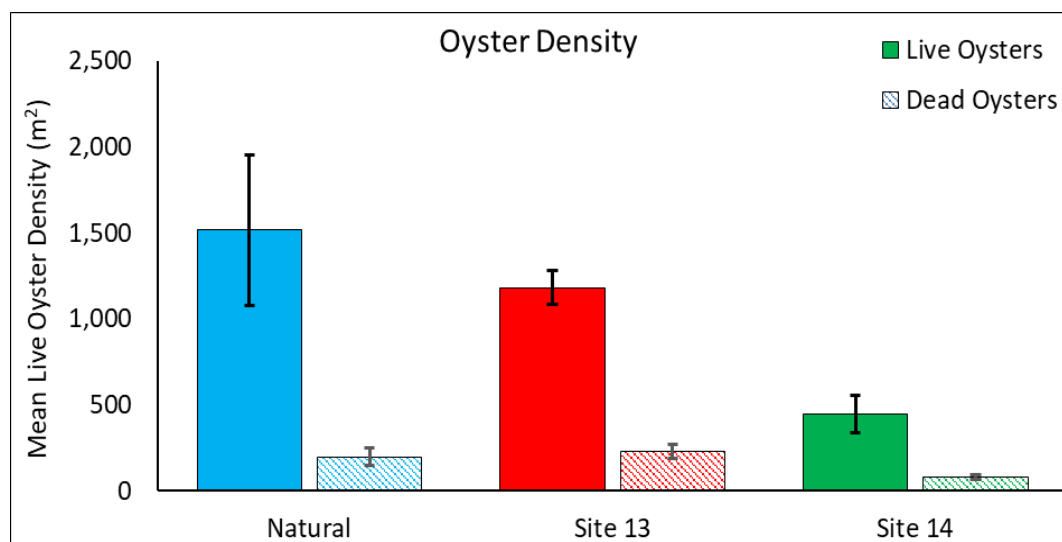
Oyster density was variable between the oyster reefs and among the sample points within each reef (Figure 4). The highest overall live oyster density was found at the Natural reefs where density was 1,517 oysters m² (SE \pm 436, n=10). Live oyster density at Site 13 was also good and considerably less variable with 1,182 oysters m² (SE \pm 97, n=25). Site 14 had the lowest live oyster density with 446 oysters m² (SE \pm 108, n=40).

Density of dead oysters was substantially less than that of live oysters at all three oyster reefs (Figure 4). Mean density of dead oysters at the Natural reef was 198 oysters m² (SE \pm 52, n=10) compared to the restoration reef Site 13 which had slightly more at 232 oysters m² (SE \pm 41, n=25) and Site 14 which had the lowest dead oyster density of 79 oysters m² (SE \pm 14, n=40).

Figure 4. Mean density of live oysters (solid bars) and dead oysters (cross hatch bars) among the three oyster reefs. Error bars indicate 1 SE.

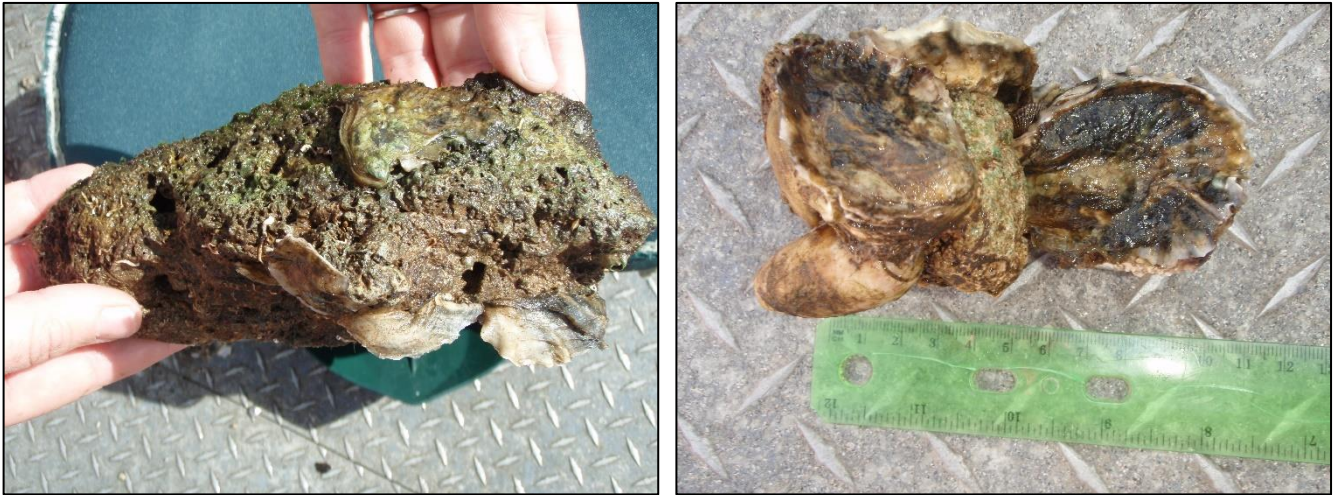
found on Florida's beaches. Most of the material consisted of various sized seashells that ranged in size from about 1 cm up to about 10 cm. Additionally, amongst the shells were many sandstone rocks ranging in size up to about 15 cm (see Photo 4).

Photo 4. The NOAA restoration reefs were created using sandstone rock and various seashells that were undesired components of a local beach renourishment project. Photos show oysters attached to different size pieces of sandstone rock which appeared to exhibit the best results for recruiting oysters.

In the first reef assessments conducted during the early years following reef construction, it was noted that there was an apparent preference of material type that a disproportionate number of the oysters were settling and growing on. Most sandstone rocks of all sizes, especially the larger ones, seemed to have the highest number of oysters growing on them. Additionally, oysters were observed attached to the larger seashell material. However, oysters were seldom observed attached to seashells measuring smaller than about 2 cm.

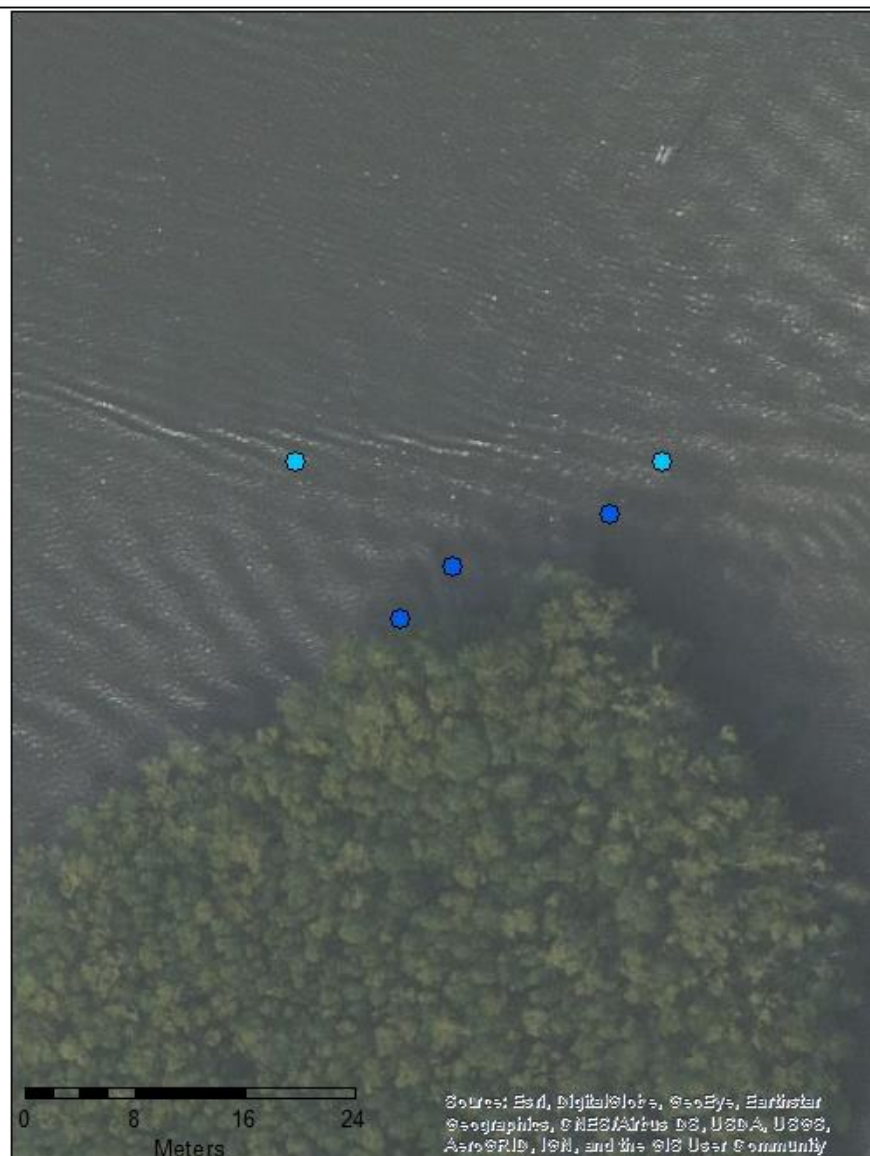
Map 1a

Oyster viability shown as the percentage of live oysters counted at each sample point at the upstream (left) and downstream (right) natural oyster reefs.

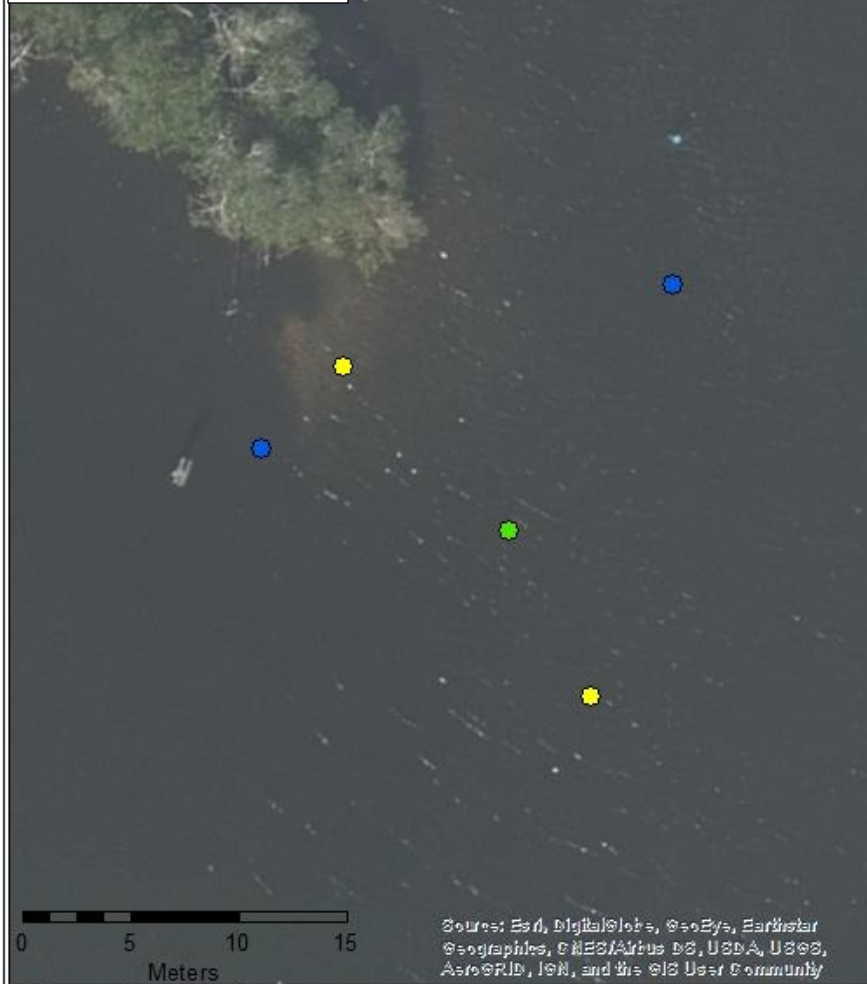
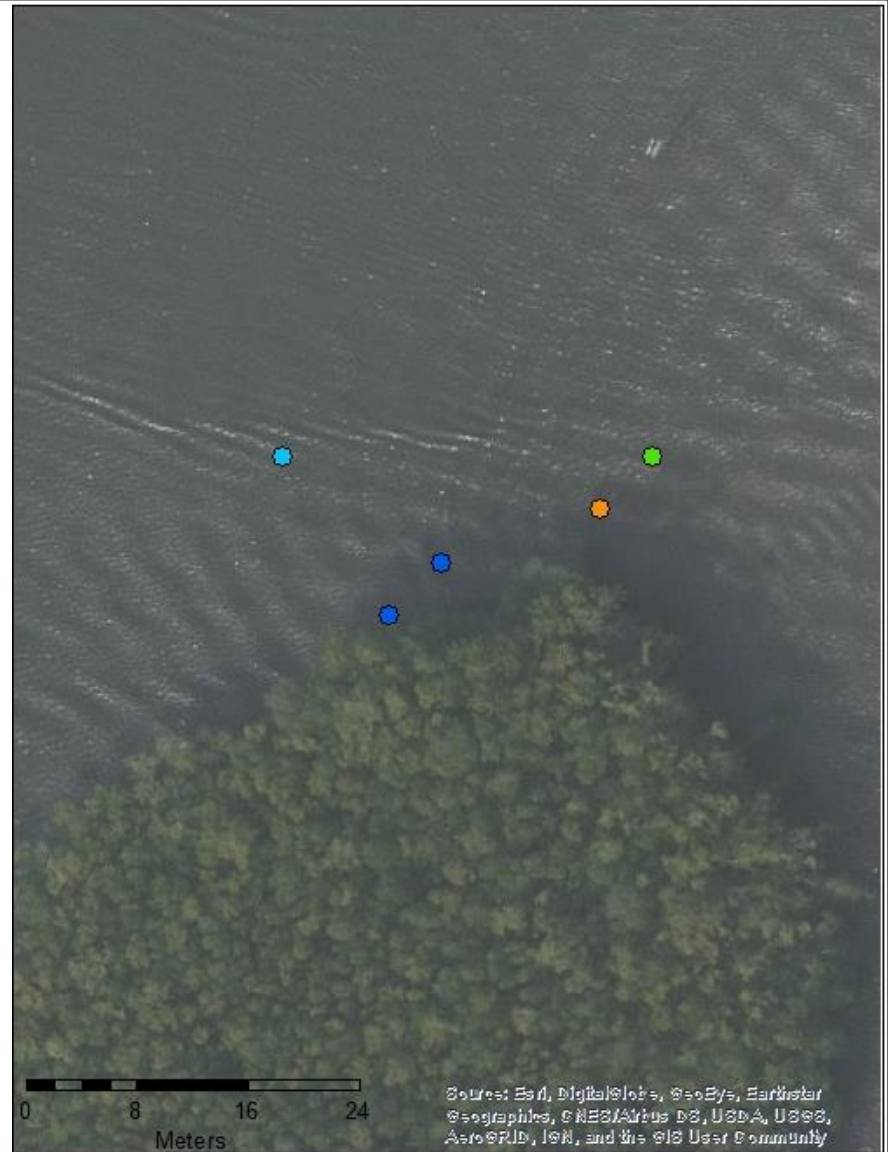
Map 2a

Mean live oyster density (per m²) at the upstream (left) and downstream (right) natural oyster reefs.

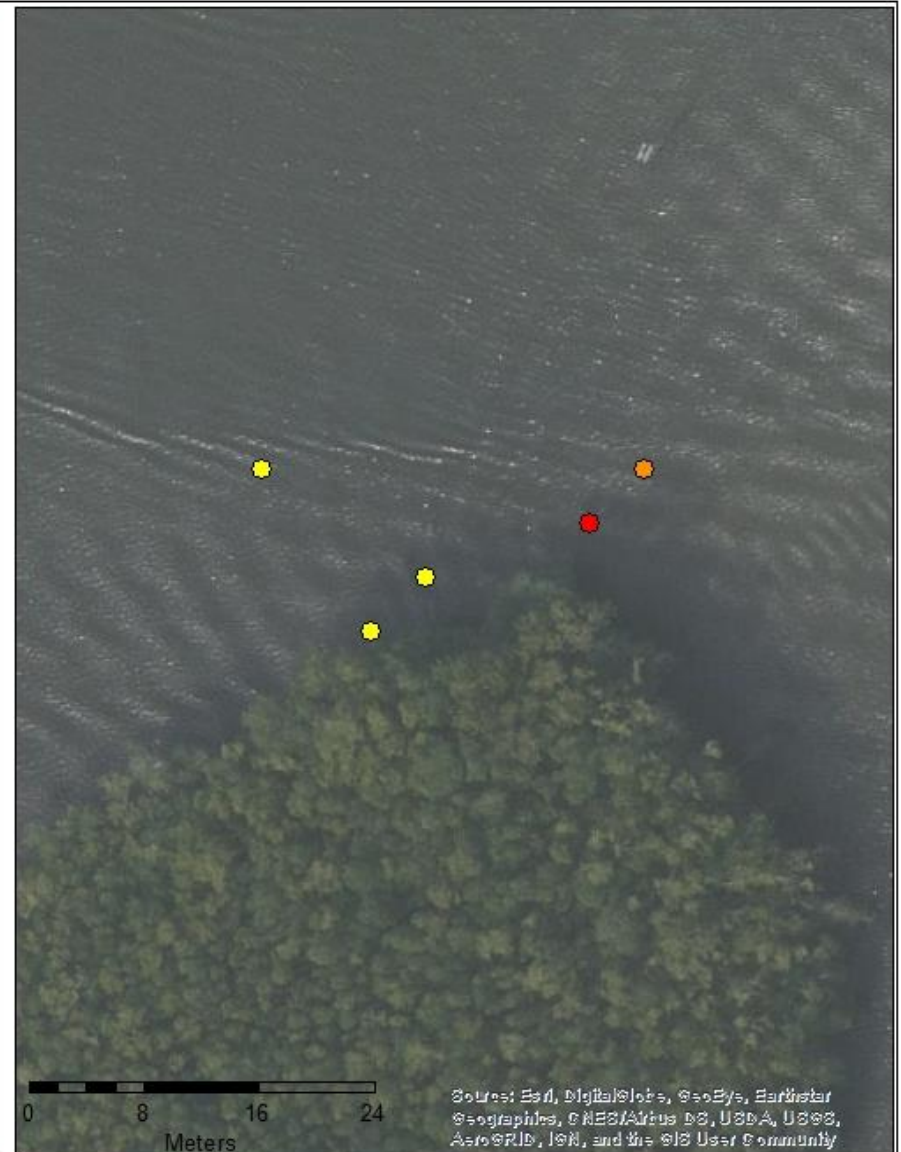
Map 3a

Mean dead oyster density (per m²) at the upstream (left) and downstream (right) natural oyster reefs.
