**LOXAHATCHEE RIVER DATASONDE WATER QUALITY MONITORING**

**TASK 2: FINAL REPORT**

**ASSESSMENT OF 2007-2008 LOXAHATCHEE RIVER WATER QUALITY**

**Loxahatchee River District**

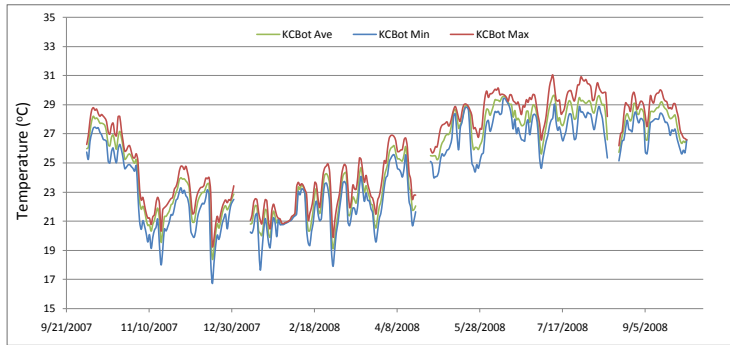
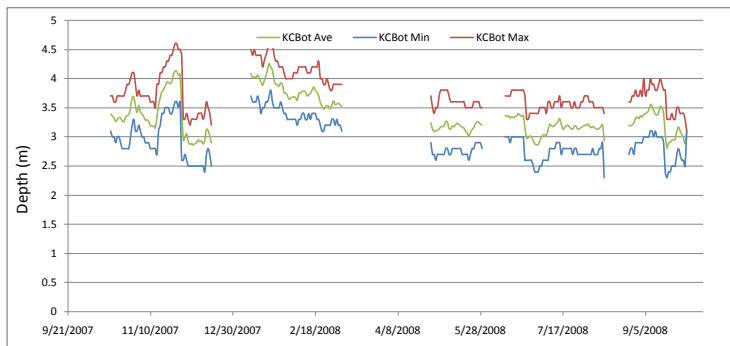
Station Kitching Creek (Bottom) daily average, minimum, and maximum of water quality parameters measured by Datasonde recording at 15 minute intervals, Loxahatchee River, Florida. Data not meeting quality control criteria excluded.

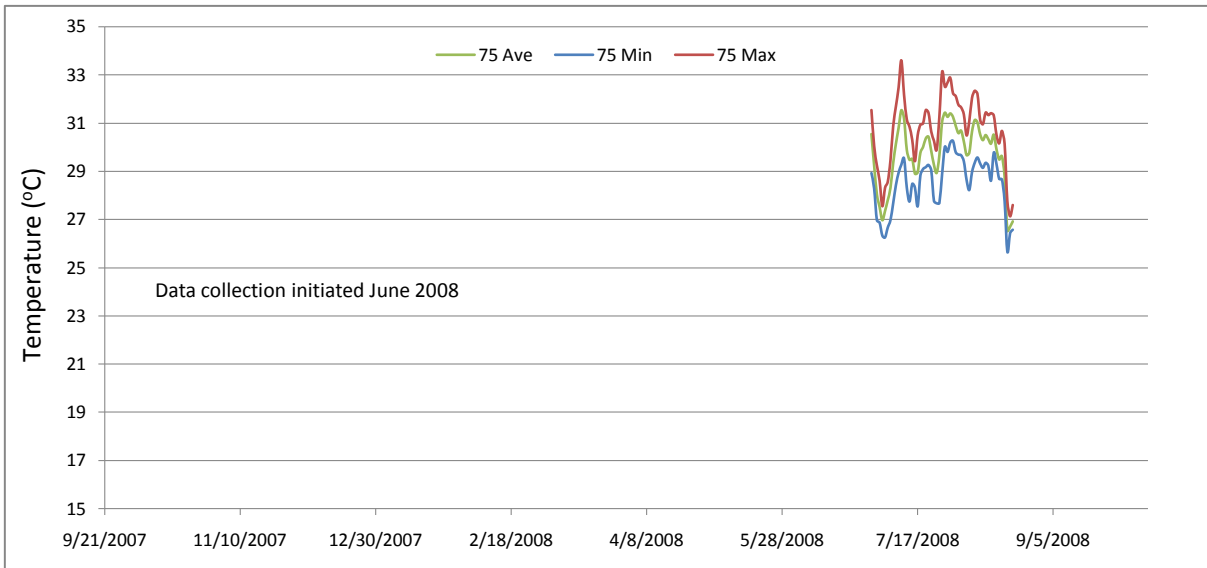
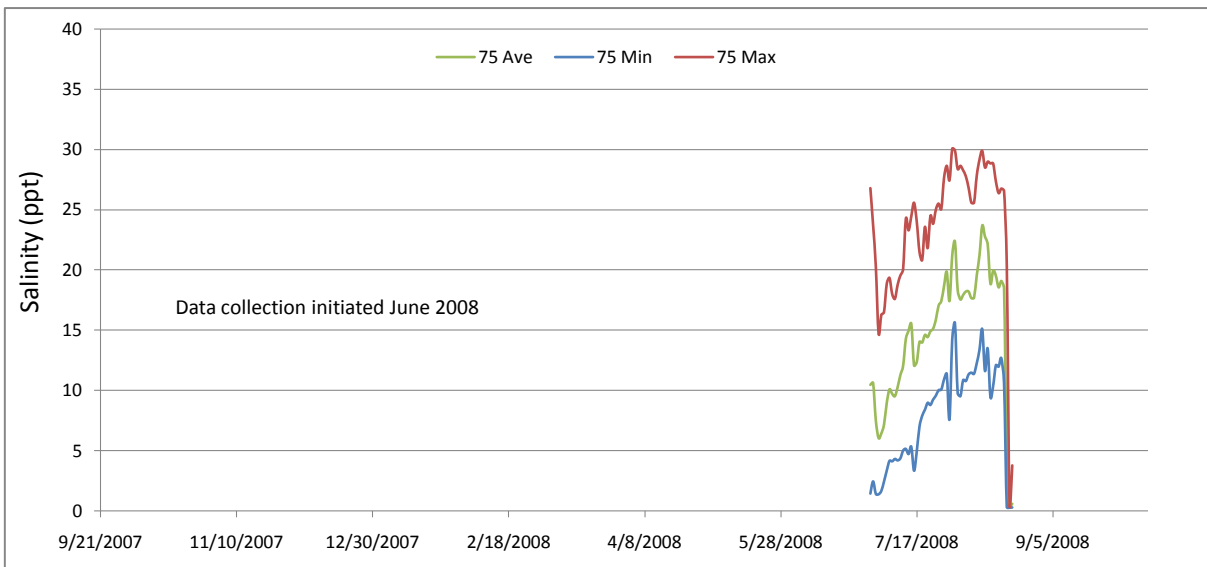
Station 75 daily average, minimum, and maximum of water quality parameters measured by Datasonde recording at 15 minute intervals, Loxahatchee River, Florida. Data not meeting quality control criteria excluded.
