Loxahatchee River Oyster Reef Restoration Monitoring Summary - 2011

Bud Howard
Loxahatchee River District, Wildpine Laboratory
2500 Jupiter Park Drive, Jupiter FL, 33458
(561) 747-5700
www.loxahatcheeriver.org

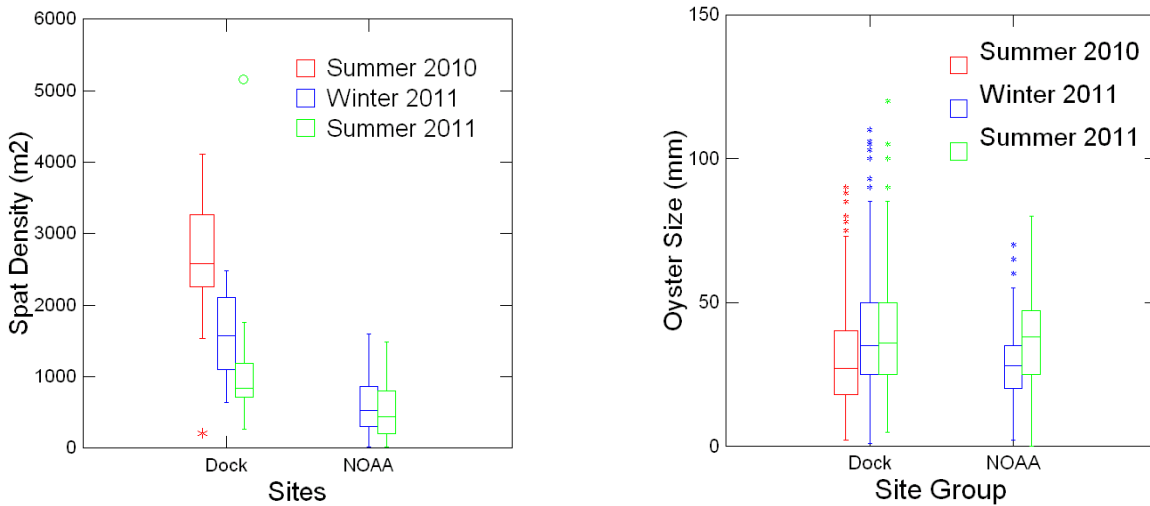
Figures 2 (Left) and 3 (Right). Plot of oyster density (left) and size (right) over time at both the dock and NOAA restoration sites. The trend for both projects show a decrease in oyster density and increase in oyster size as the reef matures.

Both oyster reef restoration projects (Dock and NOAA) have showed rapid and dense oyster settlement. At the dock sites, approximately 12-24 months after construction, median densities ranged from 1,000 to 2,500 post-settlement spat/oysters per square meter (Figure 2). For the NOAA sites, 6 and 12 months after construction, median densities were roughly 500 oyster spat per square. The range of oyster spat densities at the older dock sites reached over 4,000 spat/m². The ranges of spat densities were generally lower at the newer NOAA sites than the dock sites, but several samples exceeded 1,000 spat/m² on the NOAA sites. It is likely that the construction methodology used under the docks (i.e., placing bags of oyster shell) contributed to the significantly higher oyster spat densities observed under the docks, because placement of bagged oyster shell creates a larger amount of vertical habitat space. And, it seems the higher spat densities may simply be more larval oysters settling on a larger amount of available space. Nonetheless, the age and size of the restoration sites also may contribute to the varying oyster densities observed among the restoration projects.

Median size of live, post-settlement oysters at the restoration sites gradually increase over time (Figure 3). At dock sites median oyster size was 25 mm, though some oysters exceeded 75 mm only 12 months after construction. Several oysters exceeded 100 mm within 24 months following construction. At the NOAA restoration sites, median oyster size was over 25 mm, with several oysters over 60 mm just 6 months after construction. As the restored oyster reefs mature, we have observed oyster densities decline while oyster size has increased (Figures 2 and 3). Our monitoring data clearly show several oyster recruitment events over time. Based on the Winter and Summer 2011 monitoring (12 and 18 mo. after construction) of the Dock sites, perhaps the restored reefs in the Loxahatchee quickly mature with median oyster size of approximately 40 mm (Figure 3). This median size is comprised of juvenile oysters settling on and growing over older oysters with only a few oysters able to grow larger than 75 mm. It will

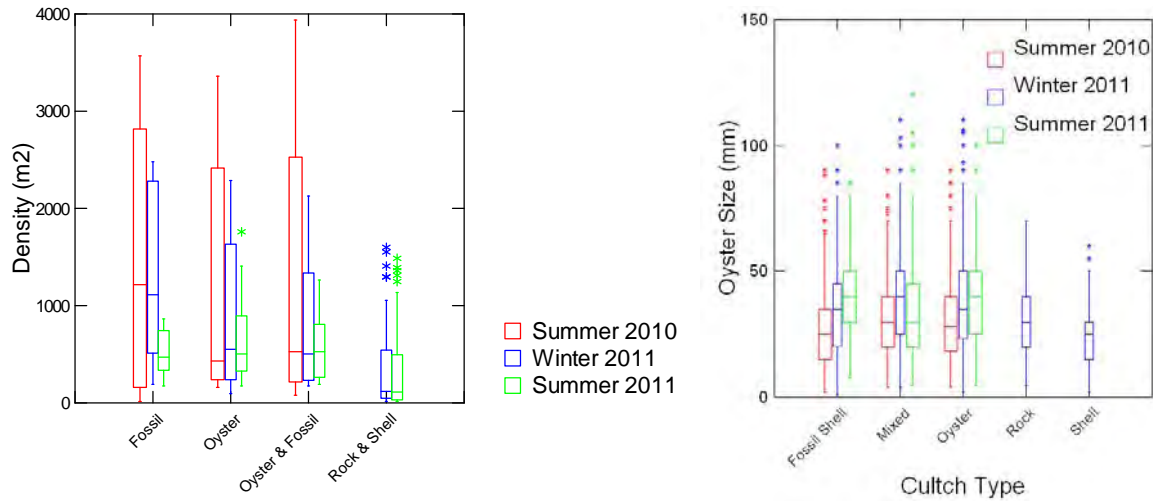
Figures 4 (Left) 5 (Right). Plot showing oyster density (left) and size (size) over time for each type of substrate used for the oyster dock and NOAA restoration projects. “Fossil Shell”, “Mixed”, and “Oyster” describes material used for the dock restoration. “Rock” and “Shell” describes the material used for the NOAA restoration sites. Segregation of material was discontinued after Winter 2011 monitoring at the NOAA sites due to consolidation new oyster growth.

Another key question for these restoration projects was the performance of the various cultch materials used for restoration. The restoration materials for the Dock sites included oyster shell from area restaurants, or fossilized shell, or a combination of both. The cultch material for the NOAA project was limestone rock and shell, the byproduct from Palm Beach County’s Juno Beach Renourishment Project. All available data appear to show no statistically significant differences in substrate quality (Figures 4 and 5). Summer 2010 monitoring was approximately 12 months after construction of the dock sites, and the Winter 2011 monitoring 6 months after construction of the NOAA sites. The groupings for the density and size computations vary because density is computed from multiple shell counts, and the assumption that the base cultch material could be identified for the spat size measurements. At the NOAA sites, the delineation of the mixed base material (“Rock” or “Shell”) became impractical and was discontinued following the Winter 2011 sampling because of the extensive growth of new oysters had obscured the original cultch. These preliminary results suggest that all of these calcium carbonate materials provide good cultch for restoration work in the Loxahatchee River, as widely documented in literature for other water bodies. Moreover, these data suggest oyster restoration using fossilized shell, fresh oyster shell from restaurants, or limestone rock and shell from beach renourishment projects all equally provided high quality substrate (cultch) that was rapidly colonized by oyster larvae.

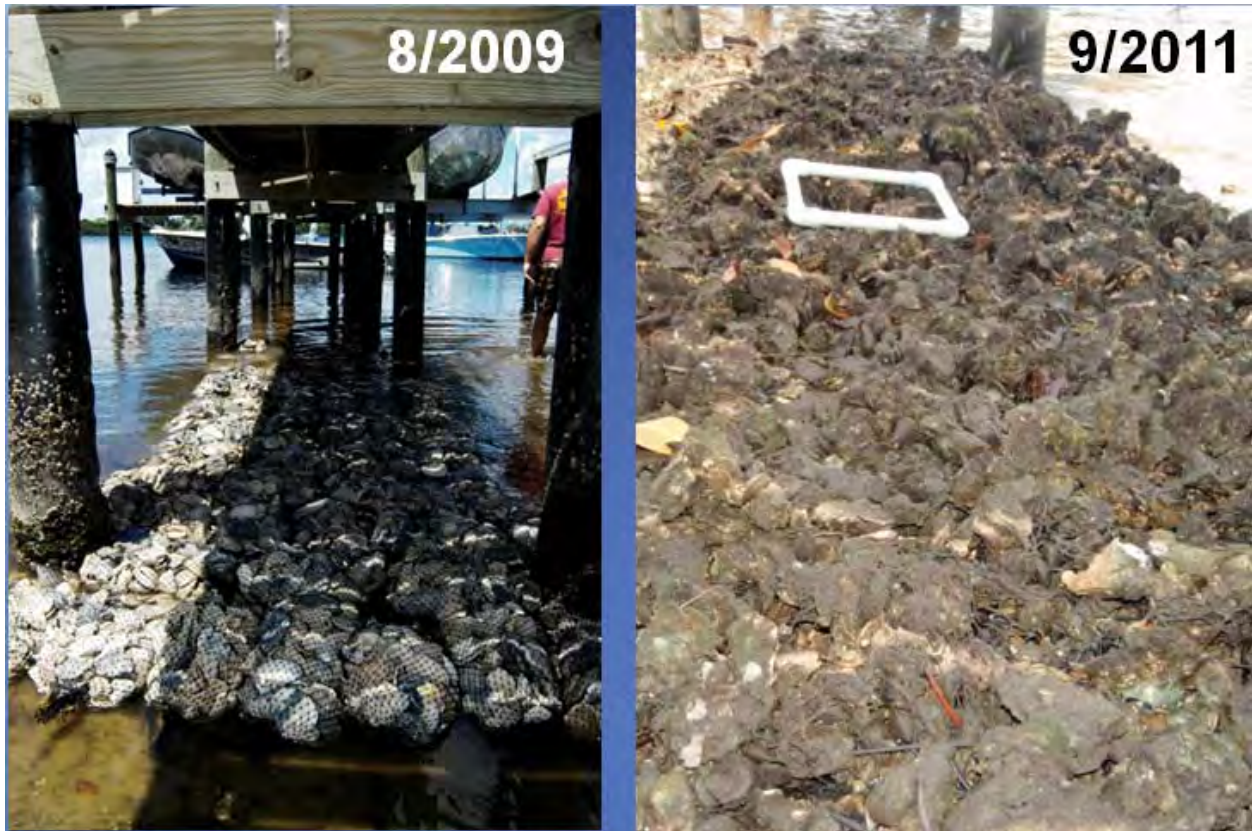
“Oyster bags” used for oyster restoration at residential docks immediately after installation(left), and two years later (right).

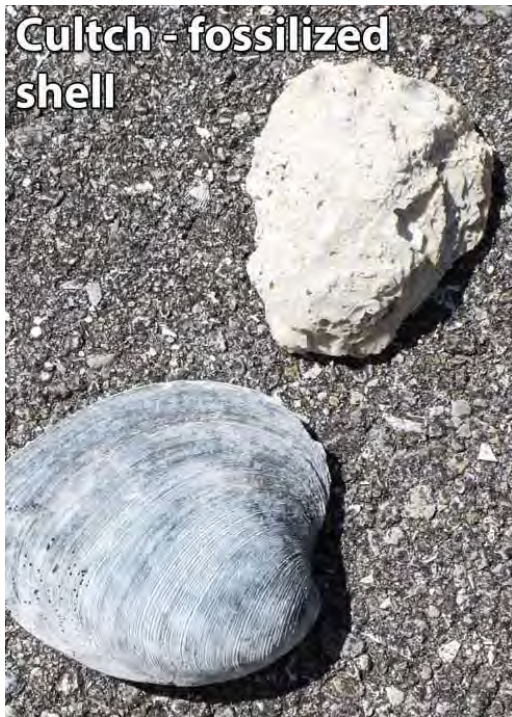
Fossilized shell used for oyster reef restoration at residential docks.

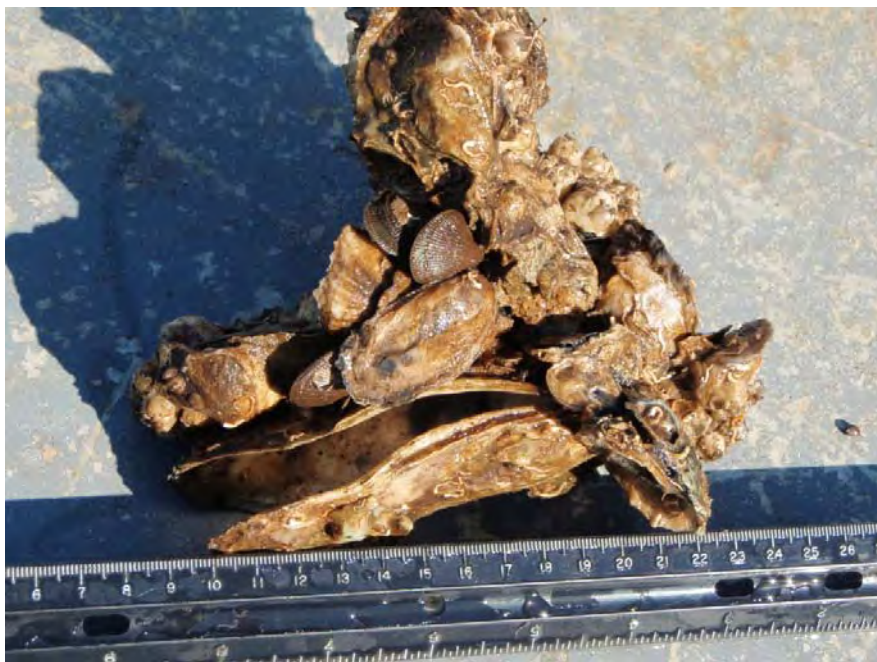
New oysters and mussels on fossilized shell from the residential dock oyster reef restoration project, 2 years after installation.

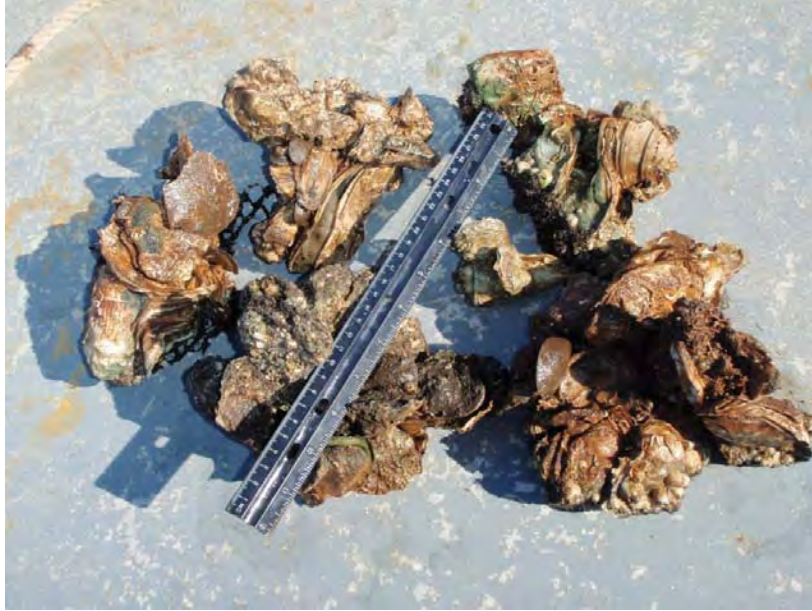
New oysters and mussels on fossilized shell from the residential dock oyster reef restoration project, 2 years after installation.

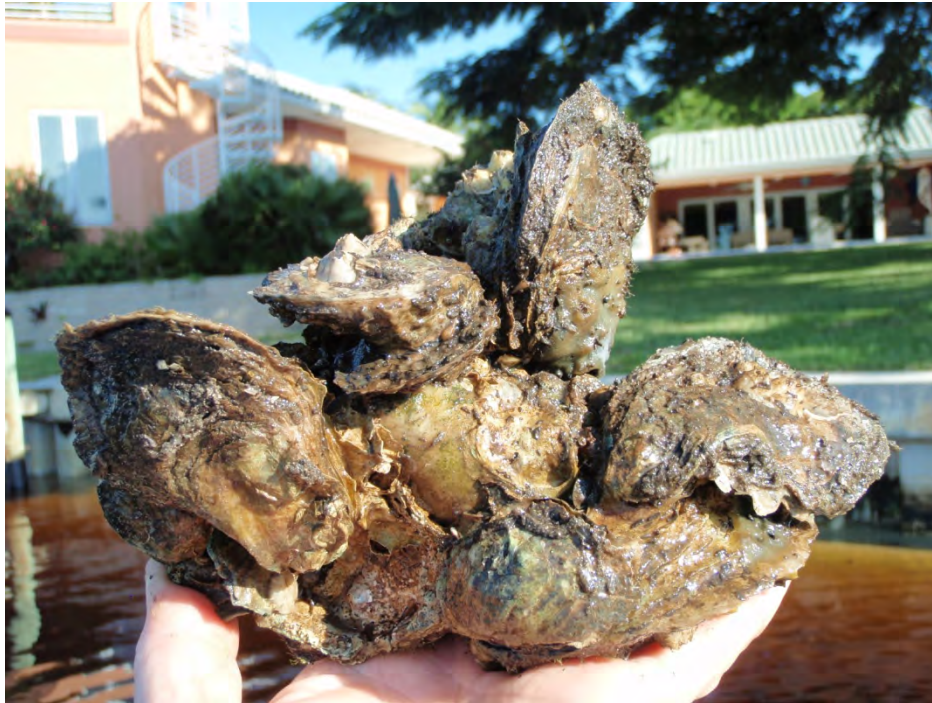
New oysters and mussels on fossilized shell from the residential dock oyster reef restoration project, 2 years after installation.

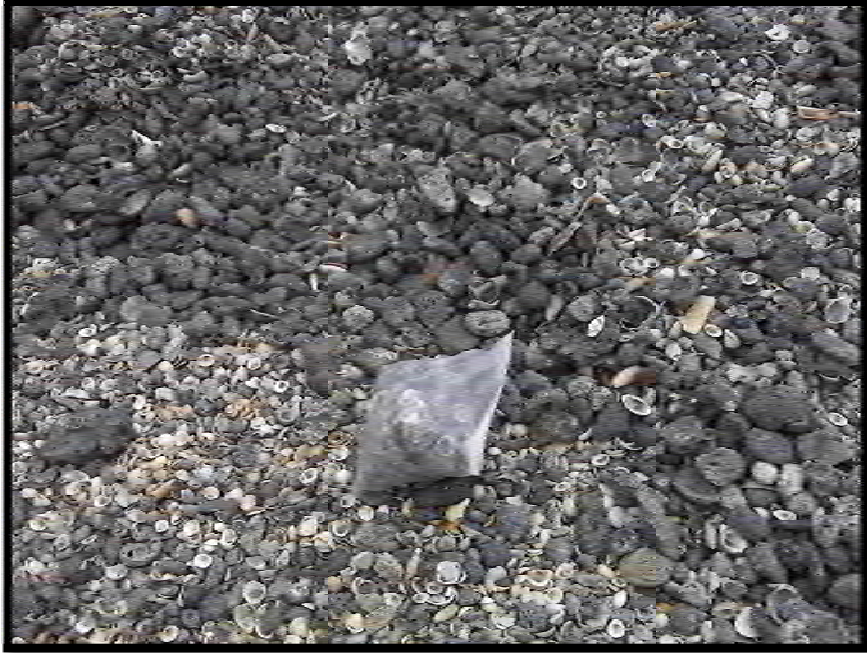
Rocks and shell used for the large-scale NOAA oyster reef restoration project. This material was the byproduct of Palm Beach County's Juno Beach Renourishment Project.

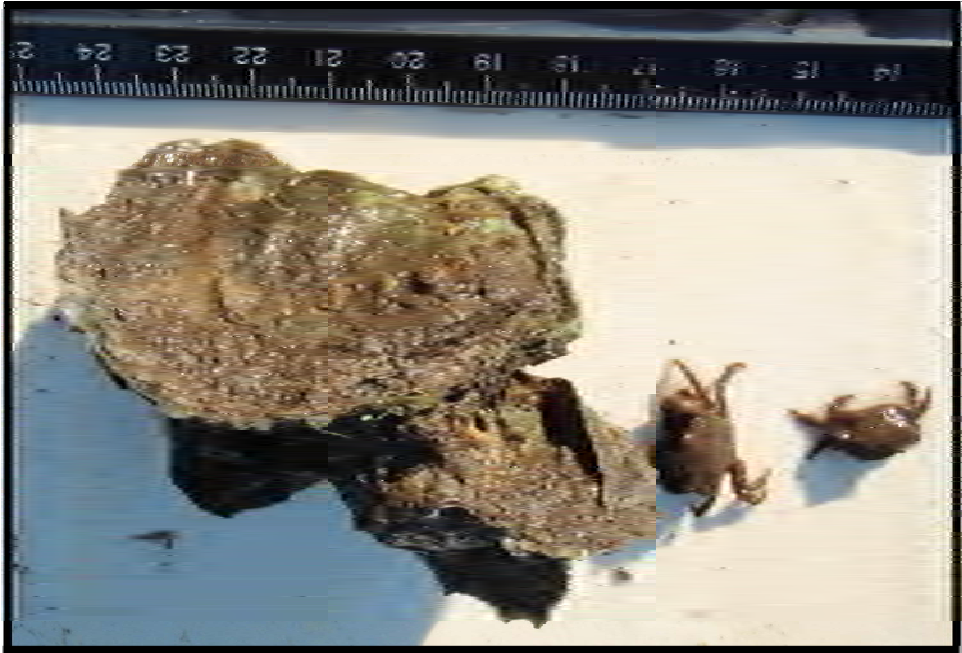
New oyster growth on a rock from the NOAA project, 12 months after installation.

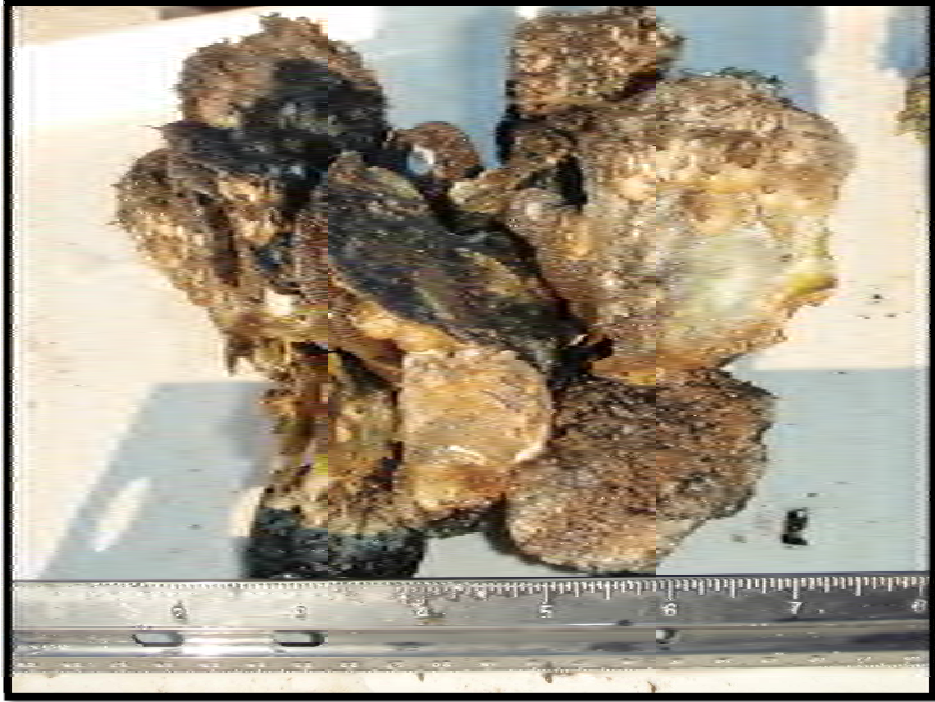
New oyster growth on a rock from the NOAA project, 12 months after installation.
