# Water Quality Response to Jones Creek Vegetation Trimming Project

*May 2023 – April 2025*

**Loxahatchee River District  
WildPine Ecological Laboratory**  
[www.loxahatcheeriver.org](http://www.loxahatcheeriver.org)

August 2025

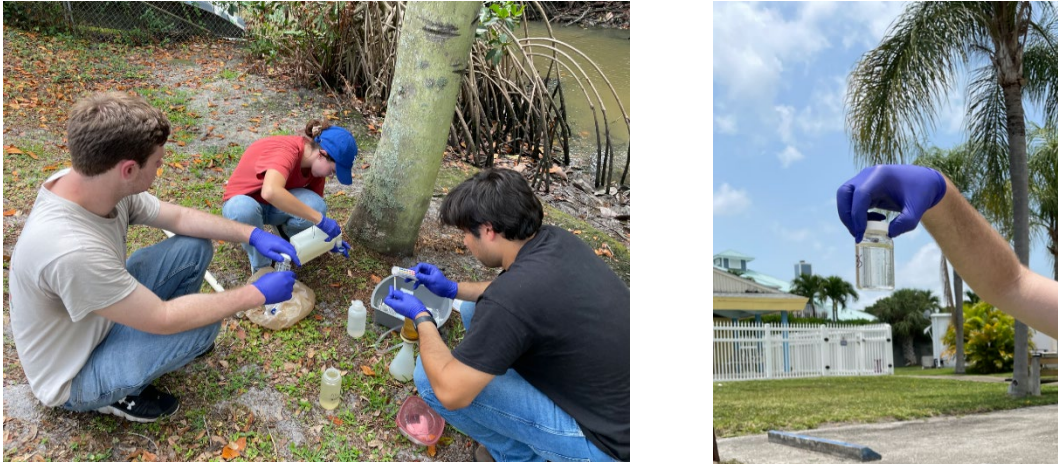
**Figure 5.** University of Central Florida students are partnering with the Town of Jupiter Water Plant Utility staff to gain water quality field experience in the environmental monitoring of Jones Creek.

All surface water field sample collection methods followed Florida Department of Environmental Protection's Standard Operating Procedures (FDEP DEP-SOP-001/01). Samples were taken at a depth of 0.3 meters to ensure consistency and comparability across sites. Laboratory analyses were conducted by LRD's Wildpine Laboratory a NELAP Recognized Accreditation Body (TNI). The laboratory maintains rigorous quality assurance protocols, including biennial proficiency testing and analyst demonstrations of capability, and analytical QC measures to ensure data accuracy and precision. All analytical methods followed protocols published by the U.S. Environmental Protection Agency (USEPA) or the *Standard Methods for the Examination of Water and Wastewater*. Detailed information

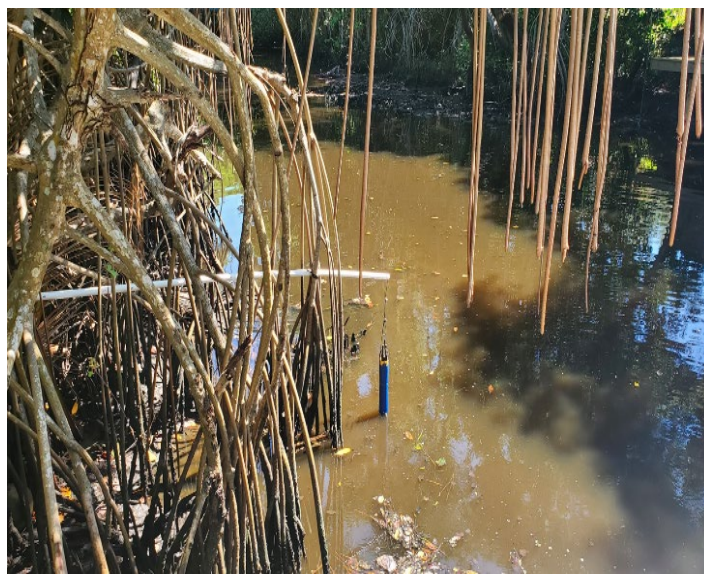
**Figure 7.** Continuous monitoring apparatus shown deployed at CALC (on left) and at TPJ (above on right).

In addition to grab samples, we monitored several water quality parameters every 15 minutes using a YSI EXO2 data sonde instrument at two stations (CALC and TPJ) for 3-month deployments before and following trimming ([Figure 7](#)). The instruments were not deployed during the trimming work because the area was regularly disturbed and to avoid unintentional damage to the equipment. An additional monitoring station JC, located near Station 75 in a non-trimmed section of Jones Creek, was used as a downstream reference/comparison site. The JC station only recorded temperature, depth, and salinity. To make comparisons of equivalent time durations, data from JC were extracted for the same pre- and post-trimming periods (August 1 – October 11, 2023, and May 30 – August 31, 2024). A summary of the instrumentation sampling sites and parameters is provided in [Table 3](#).

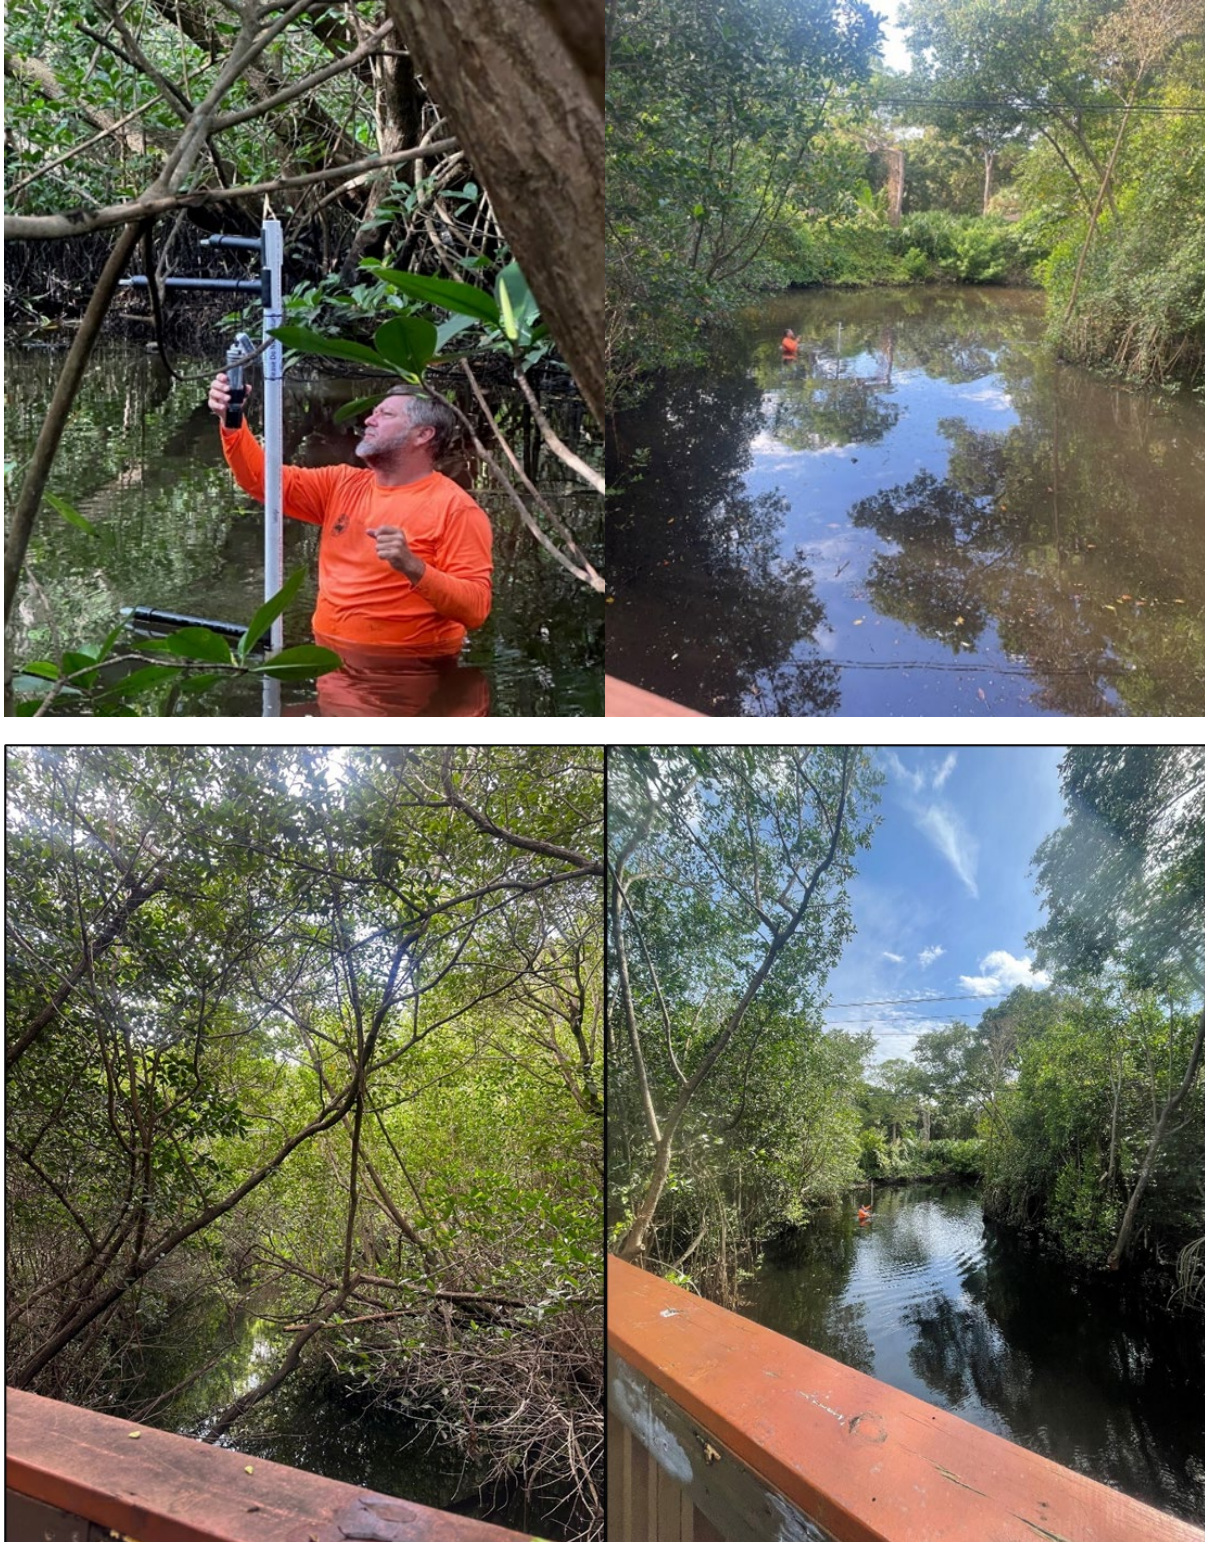
**Figure 8.** LRD Staff setting up the light monitoring apparatus at TPJ both before (left photo) vegetation trimming started and after (right photo) the vegetation trimming was completed.

An additional sensor that was unaffected by overhead vegetation was deployed to make quantitative comparisons under varying cloud cover and weather conditions. During October 2023 the sensor was placed near the mouth of Jones Creek (26.9431°N, -80.1166°W), and during October 2024 the sensor was placed in the intracoastal waterway approximately 9 km (5.5 mi) north of the study area (27.0089°N, -80.0987°W)

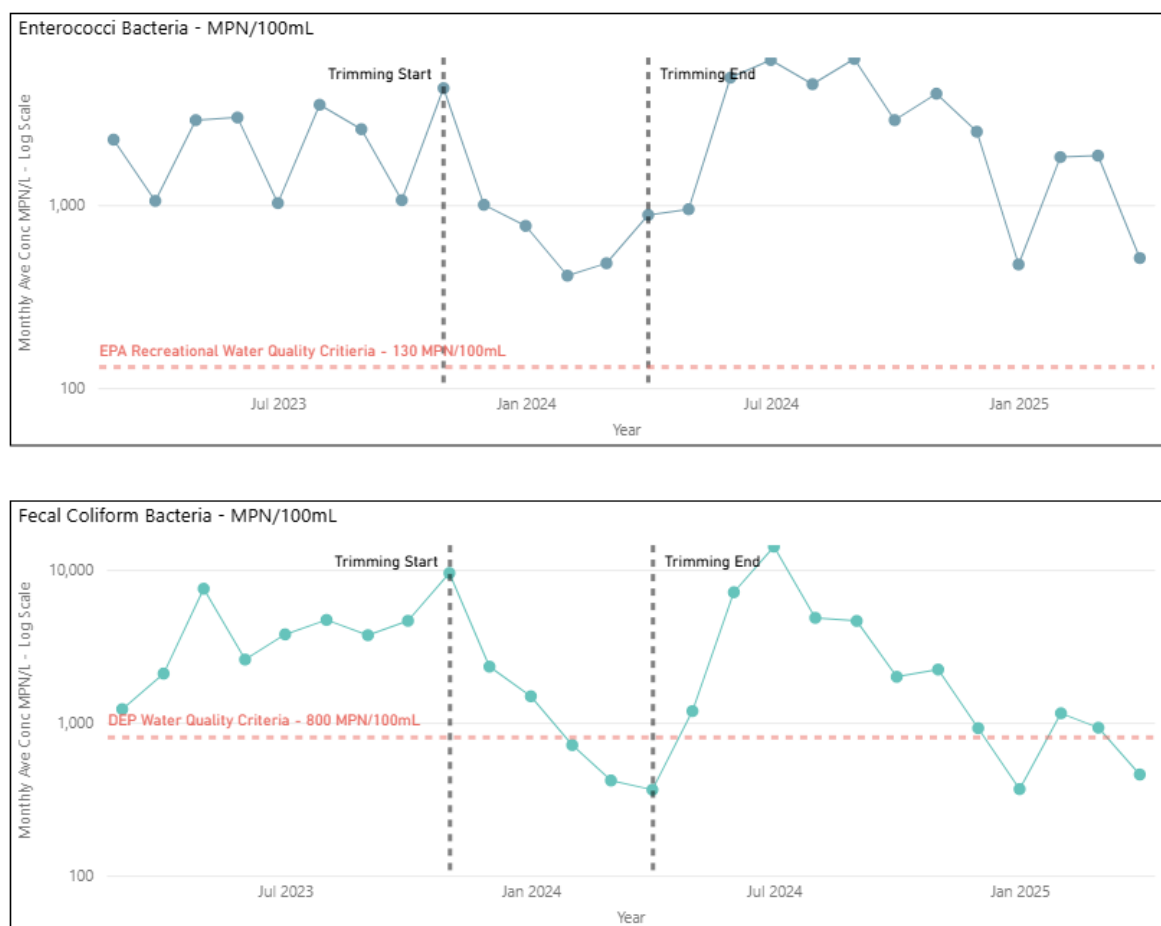
**Figure 9.** Monthly average FIB concentration (log scale) of all 6 stations sampled monthly prior to, during, and after the vegetation trimming project (May 2023 through April 2025). Note: The pre- and post-trimming sampling occurred mostly in the wet season, and the trimming work and sampling occurred during the dry season.

The monthly average of FIB concentration at the 6 stations sampled monthly are shown in [Figure 9](#). Fecal coliform and enterococci concentrations were moderate prior to the trimming work, decreased during the months that trimming occurred, and then increased following the trimming work. It is important to note that the pre- and post-sampling mostly occurred during the wet season, while the trimming work occurred during the dry season.

Because the trimming activities required extensive work in water, we expected to see increases in FIB concentrations from the mobilization of the sediments that have very high concentrations of FIB (previous unpublished work). However, despite the sediment disturbances from the in-water work, the FIB concentrations in the grab samples were generally low and typical of previous dry season samples.

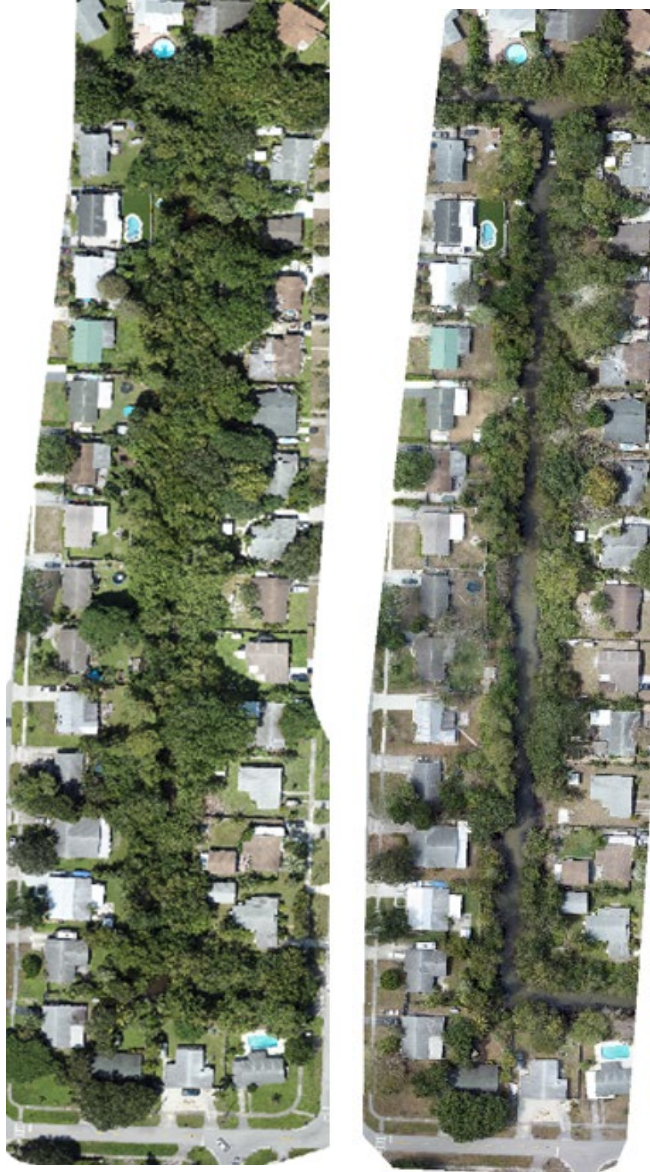
**Figure 15.** Section of Jones Creek between Delaware Street to the west, Cherokee Street to the north, and Caloosahatchee Drive to the east. Drone imagery taken before trimming (left) and after trimming (right). See Appendix for additional comparison photos.

Comparing side by side photos, you can clearly see that the vegetation has been effectively cut back to allow for greater sunlight penetration (**Figure 15**).

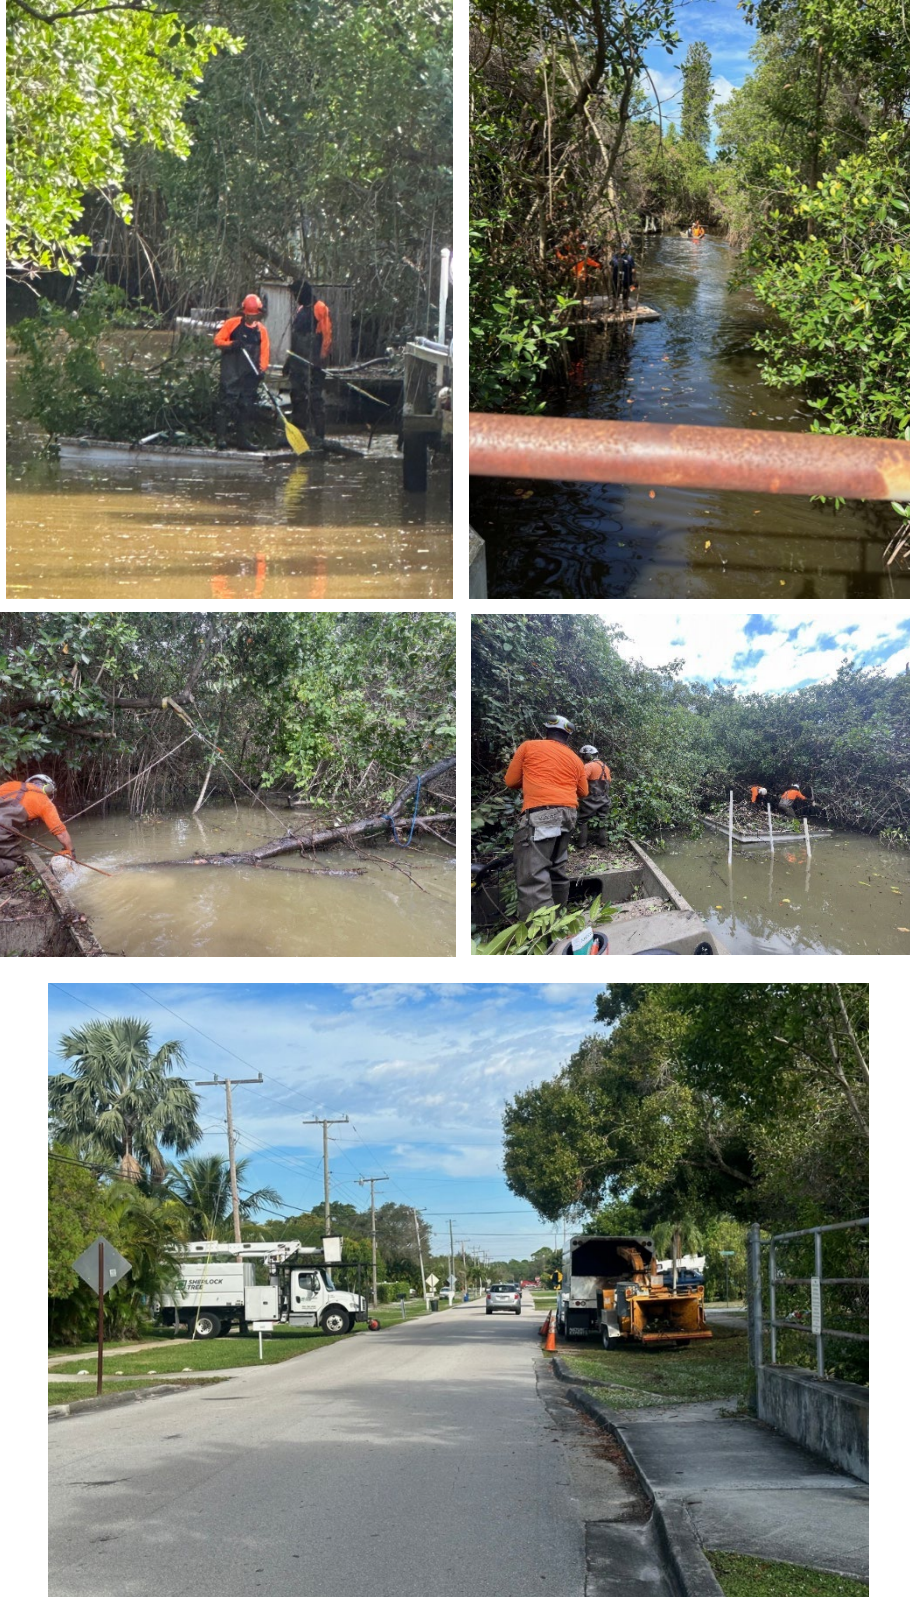
**Figure S1.** Staff from Sherlock Tree Company shown here trimming and removing exotic plants (Photos: Town of Jupiter Water Utilities and Loxahatchee River District).

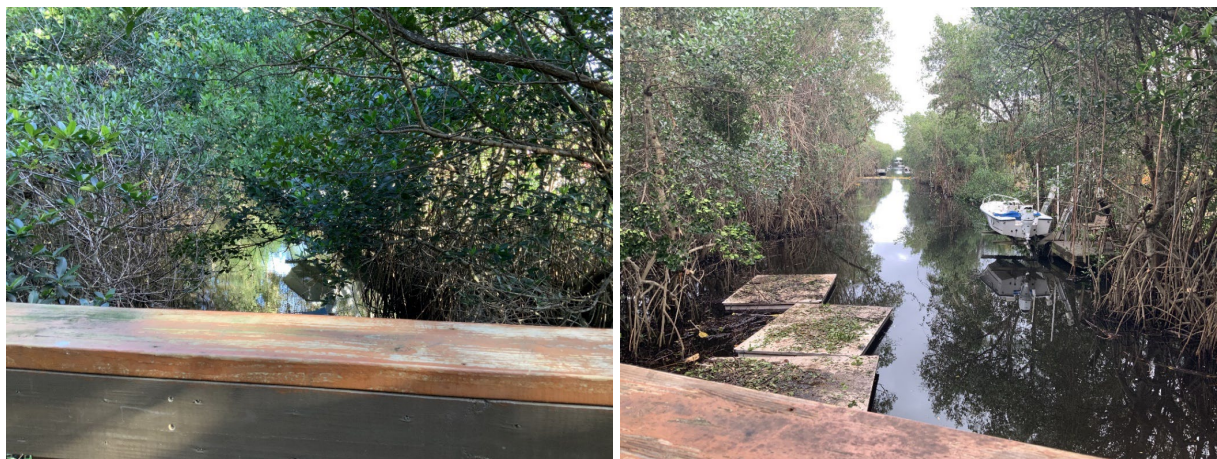
**Figure S2.** Photos before trimming (on left) and after trimming (on right) looking north from Toney Penna Footbridge (TPJ) monitoring site.

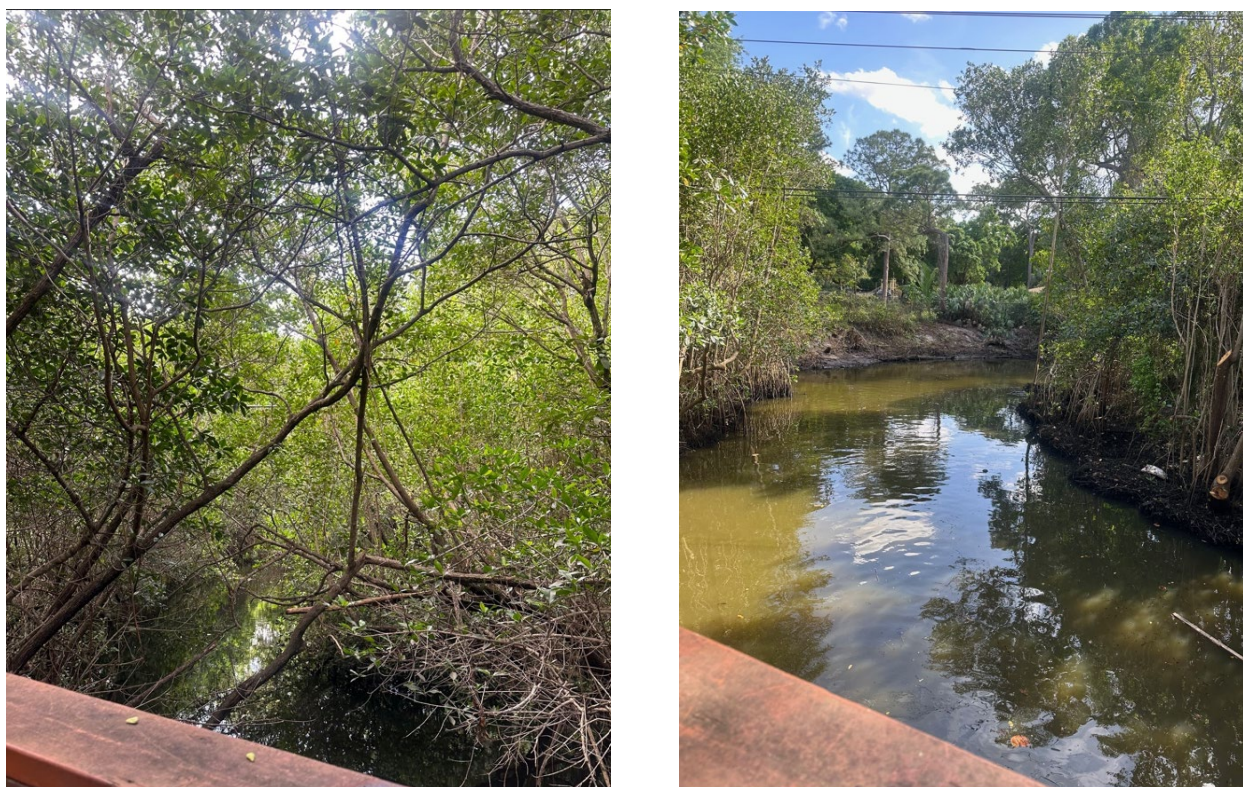
**Figure S3.** Photos before trimming (on left) and after trimming (on right) looking south from Toney Penna Footbridge (TPJ) monitoring site.

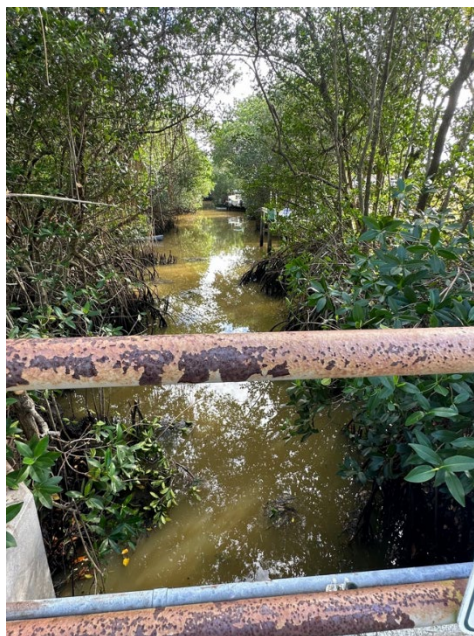
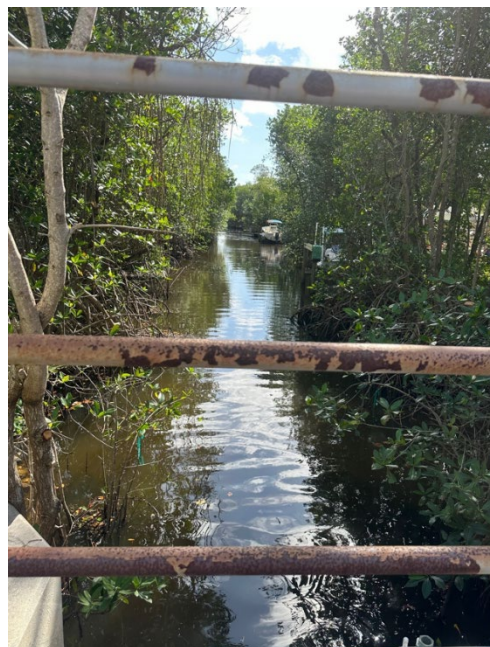
**Figure S4.** Photos before trimming (on left) and after trimming (on right) looking east from Caloosahatchee Culvert (CALC) monitoring site.

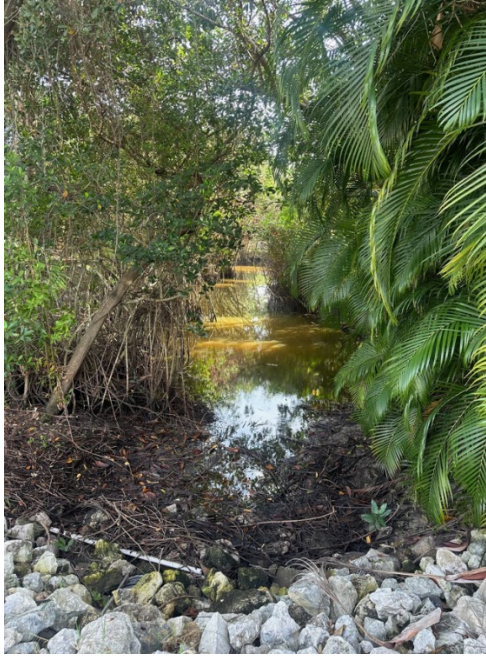
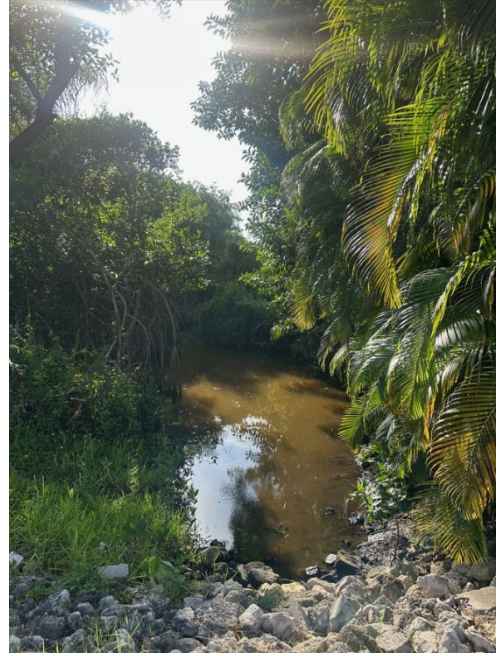
**Figure S6.** Photos before trimming (on left) and after trimming (on right) looking east from Delaware Street (DEL) monitoring site.

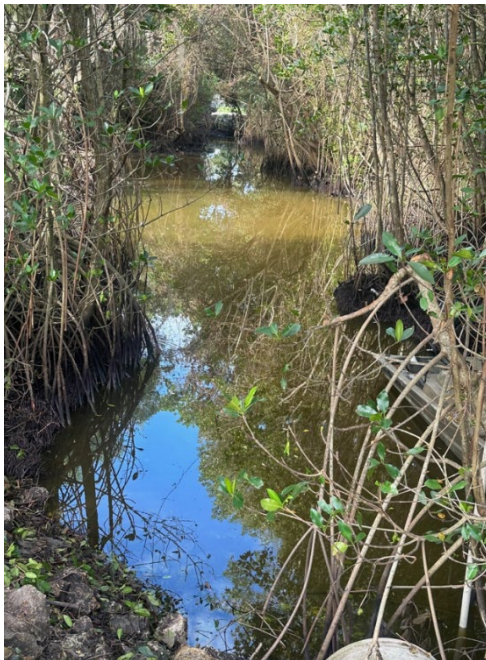
**Figure S7.** Photos before trimming (on left) and after trimming (on right) looking west toward the Delaware Street (DEL) monitoring site.

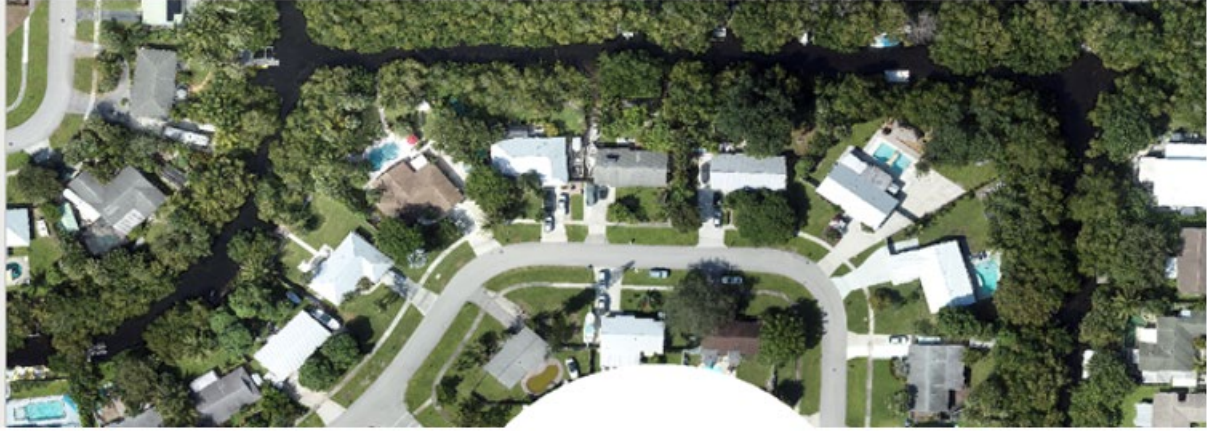
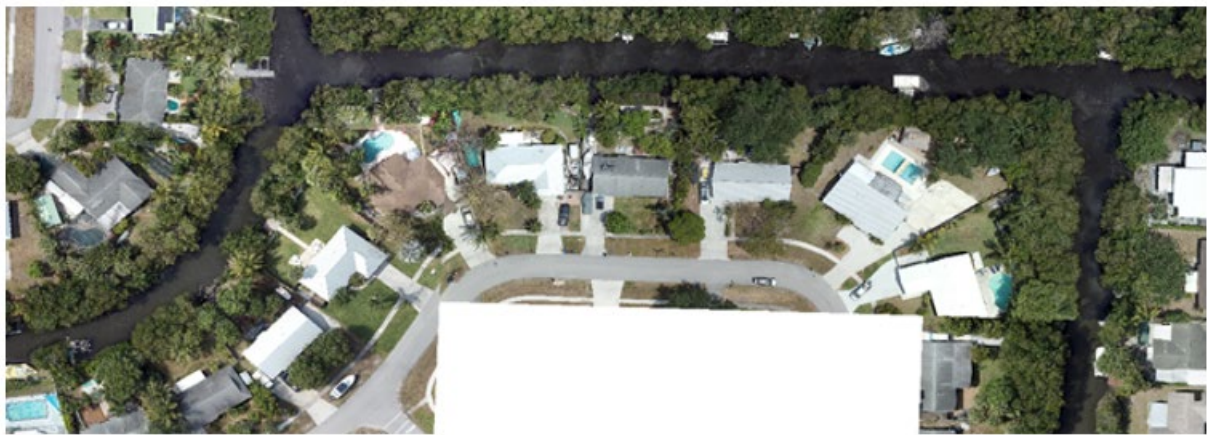
**Figure S12.** Section of Jones Creek north of Mohawk Street. Drone imagery taken before trimming (top) and after trimming (bottom).

Additional before-and-after drone images are provided in appendix **Figure S11-Figure S14**, which further illustrate the extent of vegetation removal and increased sunlight exposure.

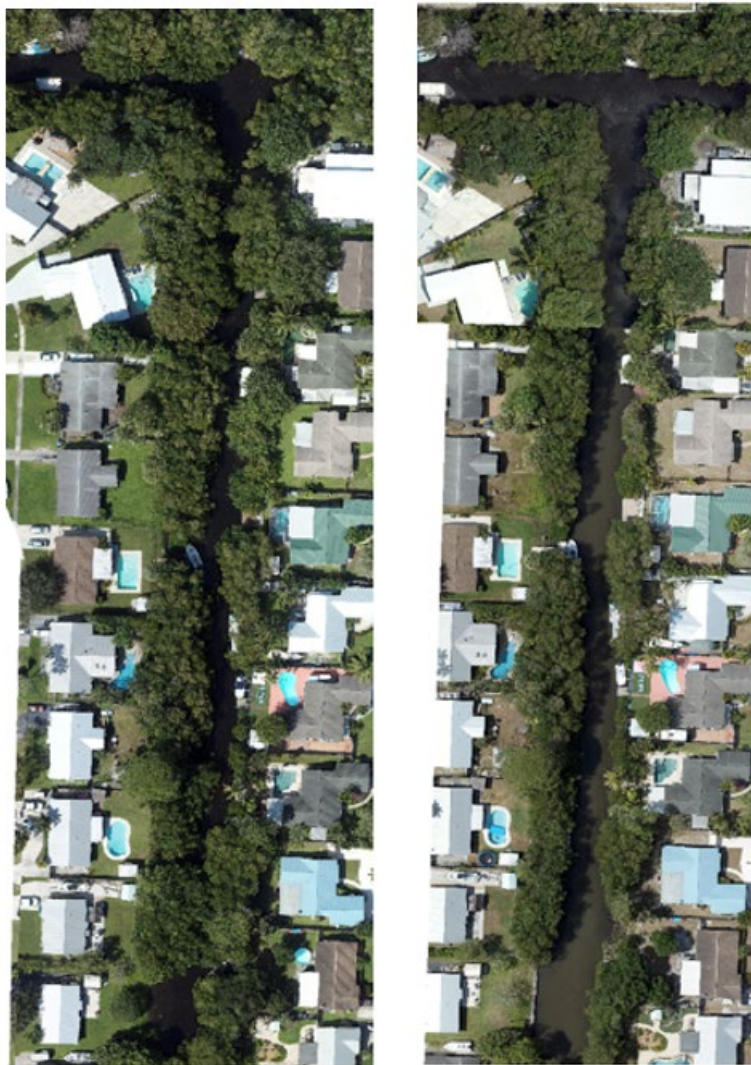
**Figure S13.** Section of Jones Creek between Pawnee Street to the west and Pennock Lane to the east. Drone imagery taken before trimming (left) and after trimming (right).

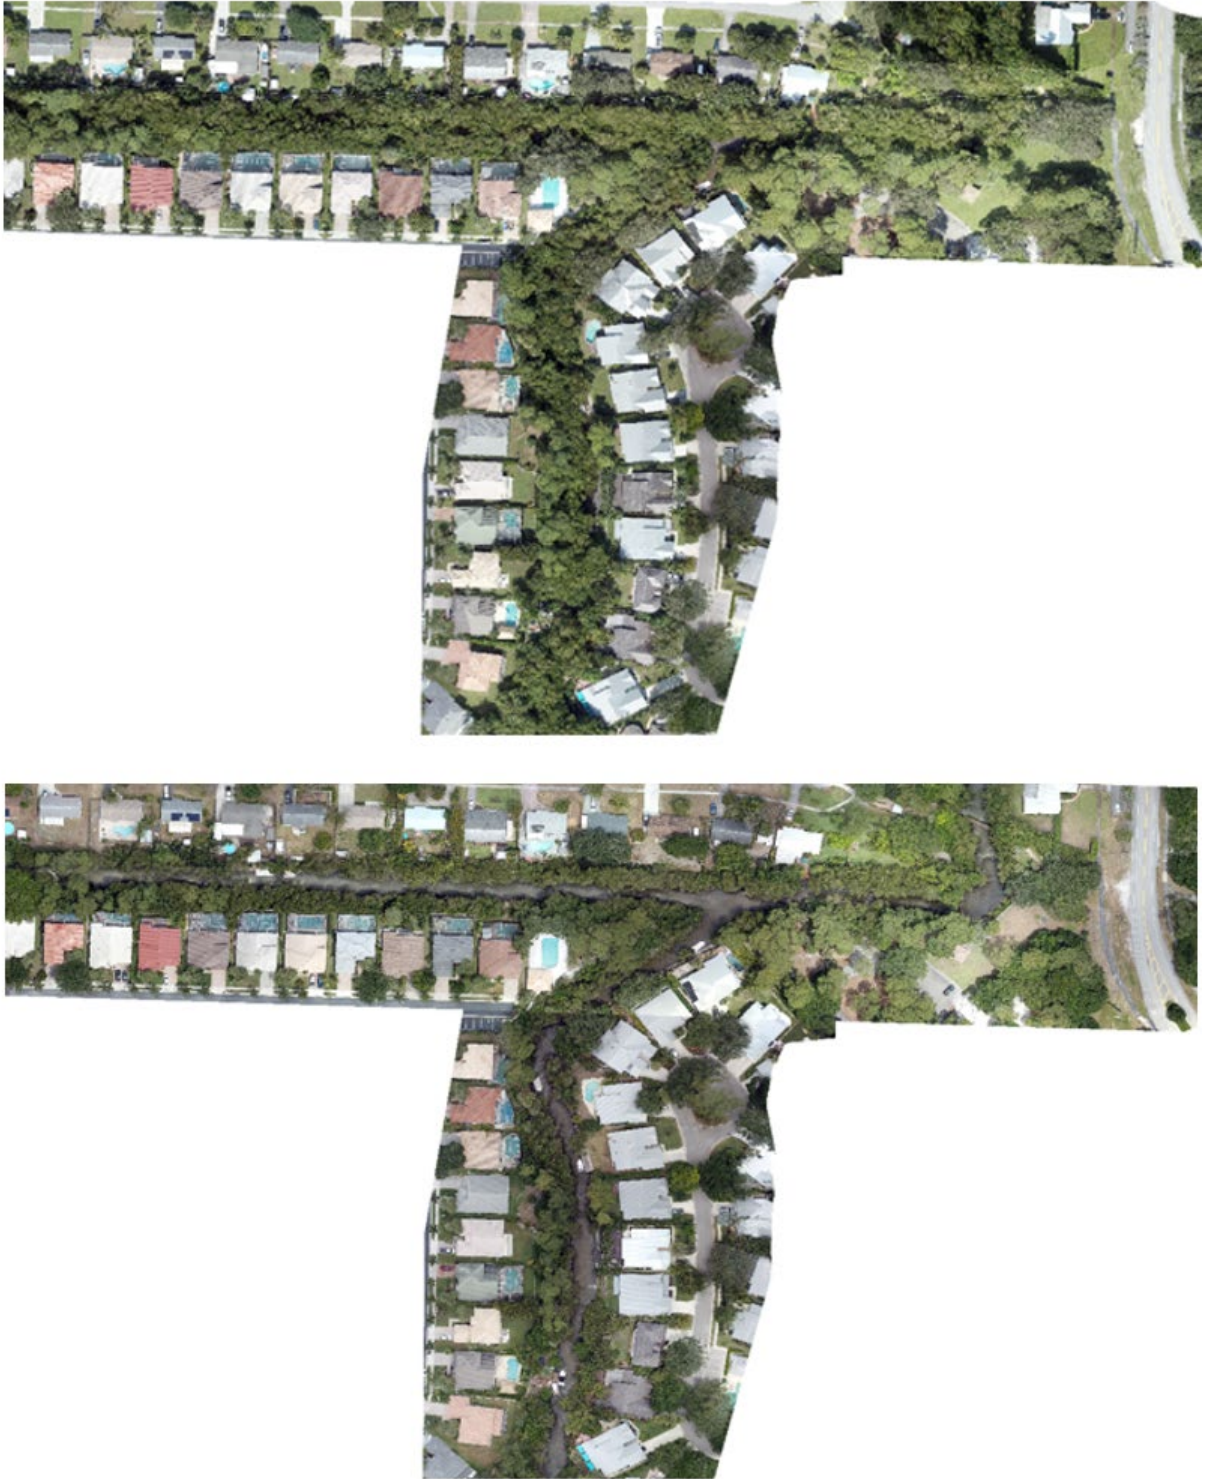
**Figure S14.** Section of Jones Creek with Mohican Blvd to the north and the Colony/Maple Isle neighborhoods. Drone imagery taken before trimming (top) and after trimming (bottom).
